Harpur Hill, Buxton, Derbyshire, SK17 9JN

Falls on Stairways – Literature Review

**Report Number
HSL/2005/10**

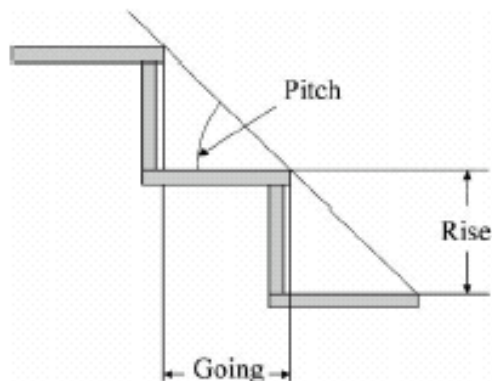
Stair geometry may be described using three terms: rise, going and pitch (Figure 1).

Rise – the vertical distance between two consecutive treads, or between a tread and a landing.

Going – the horizontal distance between two consecutive nosings. The nosing is defined as the part of the tread that overlaps the tread below.

Pitch – the angle between a line joining consecutive nosings and the horizontal.

Figure 1 – Schematic diagram of stair terminology (Roys, 2001)

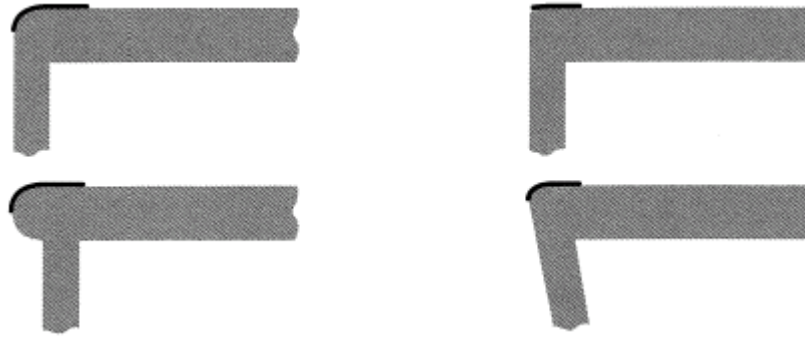
A common intervention that many employers use is to install anti slip tape to tread edges. This tape can be effective if installed appropriately. The tape should be installed on the very edge of the tread where the nosing shape is square. Where the nosing is rounded, the slip resistant material must continue at least to the vertical front face of rounded nosings (Figure 2, Roys & Wright, 2003). It should be noted that strips might move with use and subsequently become a trip hazard. Also, anti-slip strips will wear smooth over time and so should be regularly inspected and replaced when necessary.

Figure 2 – Positioning of slip resistant nosing should continue to the vertical front face of rounded nosings (Roys & Wright, 2003).
